**FINAL REPORT  
ROUND 10 DAM ASSESSMENT  
PPL GENERATION, LLC.  
BRUNNER ISLAND POWER STATION  
ASH BASIN NO. 6 WITH POLISHING POND, EQUALIZATION POND AND  
INCIDENTAL WASTE TREATMENT BASIN (IWTB)  
YORK HAVEN, PENNSYLVANIA**

**DECEMBER 20, 2012**

**GZA GeoEnvironmental, Inc.  
One Edgewater Drive  
Norwood, Ma 02062  
GZA File No. 01.0170142.30**

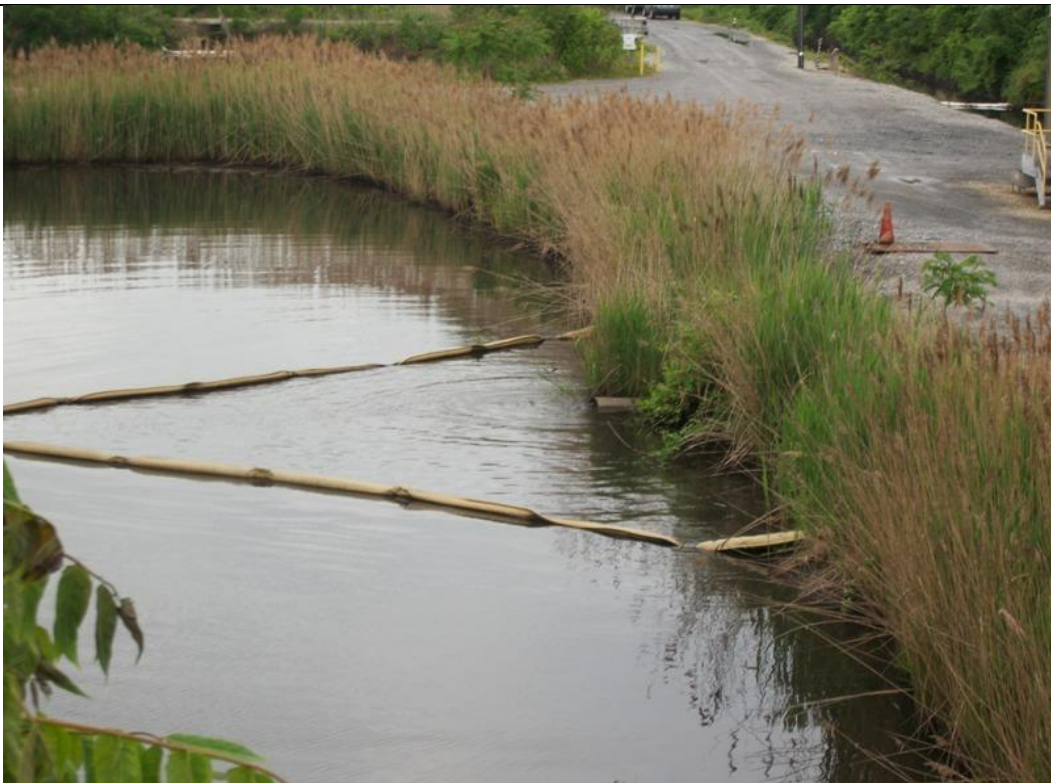
<b>Direction Photo Taken:</b> Southerly			
<b>Description:</b> Discharge outfall from Coal Pile Runoff Treatment Facility into the north lagoon. Discharge pipe is fully surrounded by turbidity curtains. Note high vegetation on inside slopes.

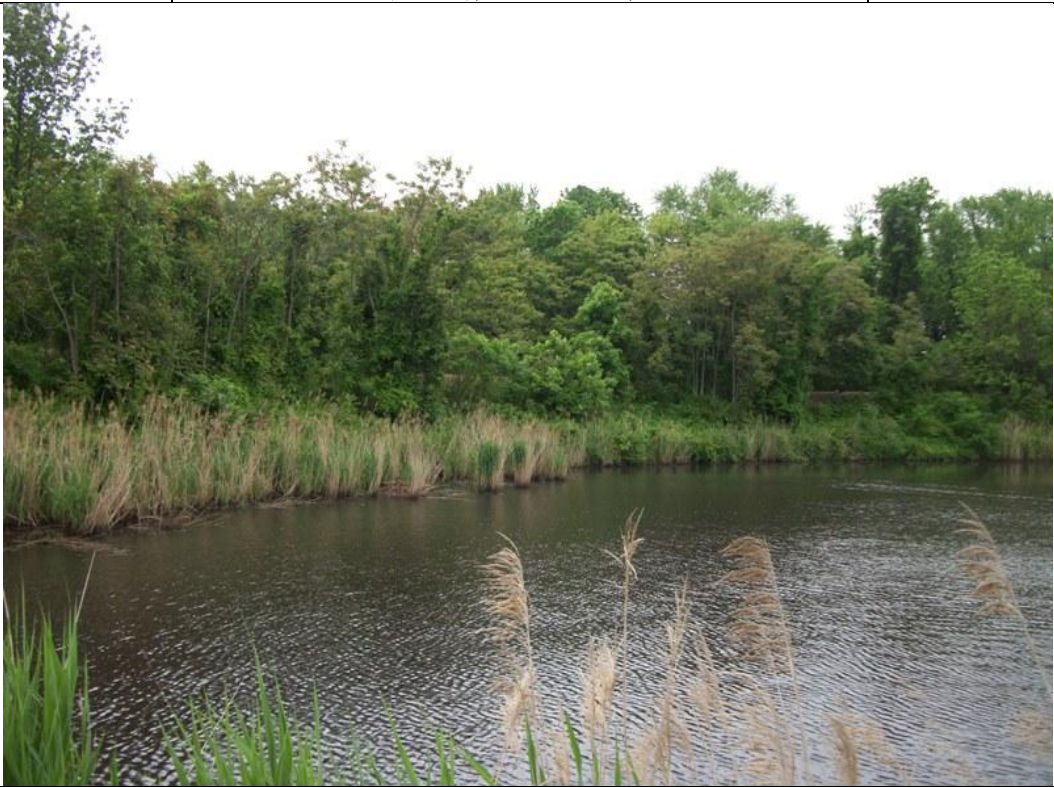
<b>Direction Photo Taken:</b> Northeasterly			
<b>Description:</b> North lagoon as viewed from the southwest. North lagoon is bounded on the north and east sides by the Susquehanna Flood Control Levee (mostly hidden just beyond the trees).			
<b>Photo No.</b> 64	<b>Date:</b> 5/18/2011

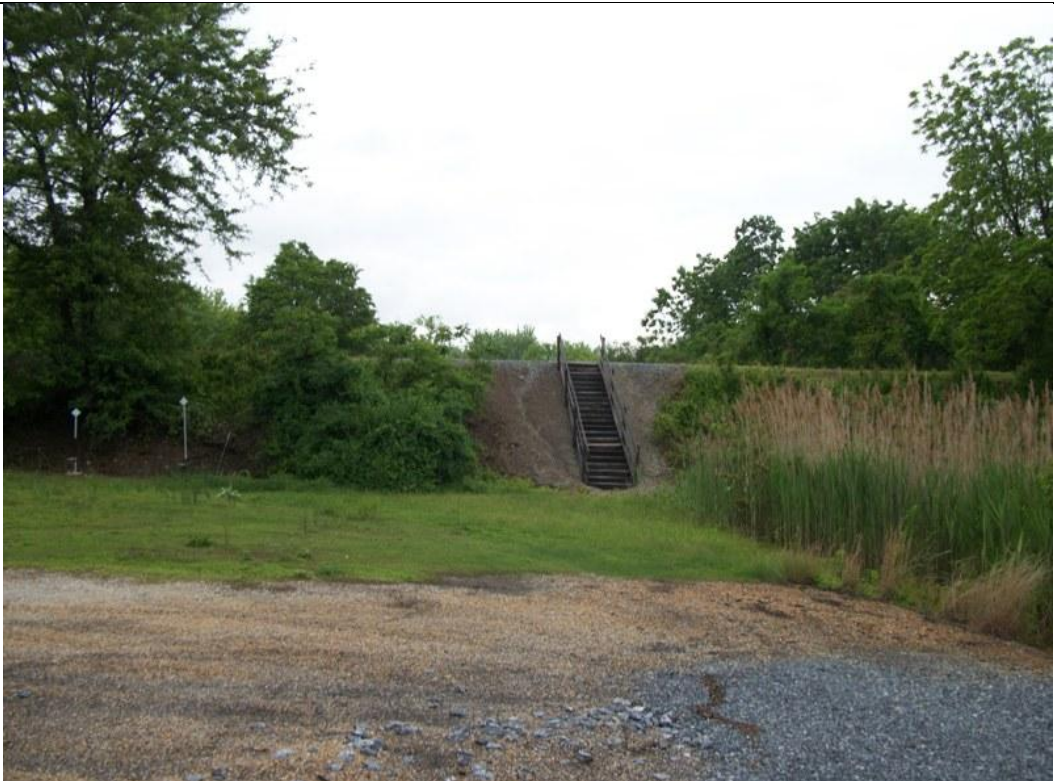
<b>Direction Photo Taken:</b> Northerly			
<b>Description:</b> View of Susquehanna Flood Control Levee which makes up the north embankment of the north IWTB lagoon (as well as the east side of the north, middle and south lagoons).

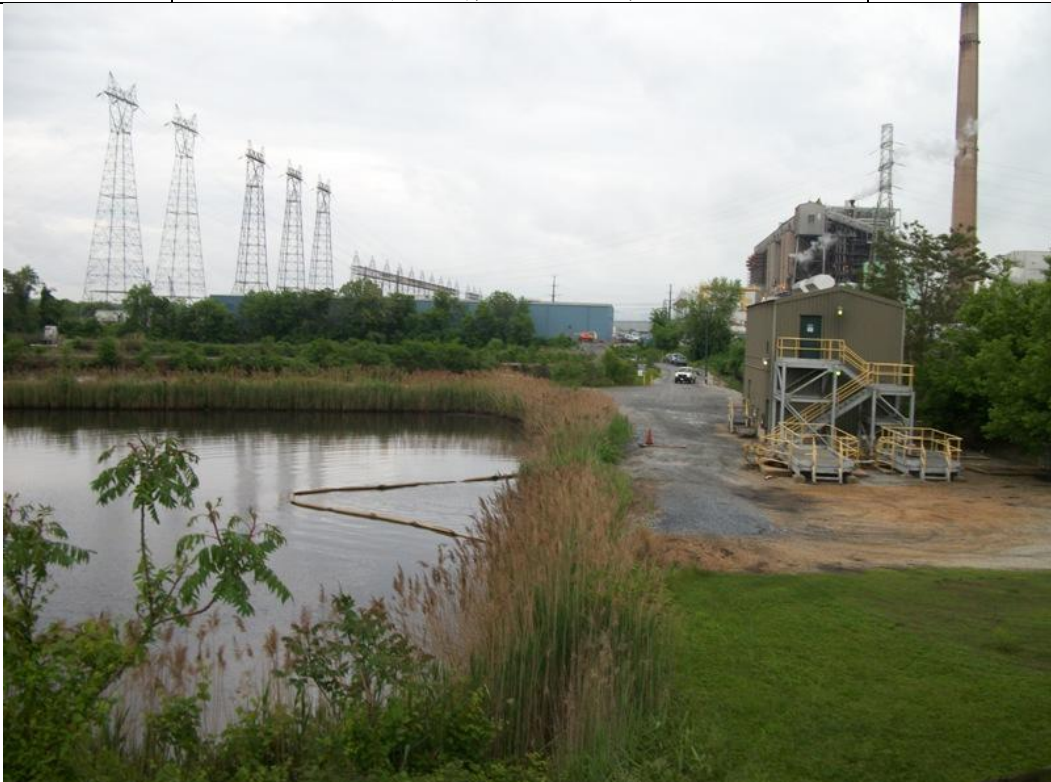
<b>Direction Photo Taken:</b> Southerly			
<b>Description:</b> View of north lagoon and the Coal Pile Runoff Treatment Facility.

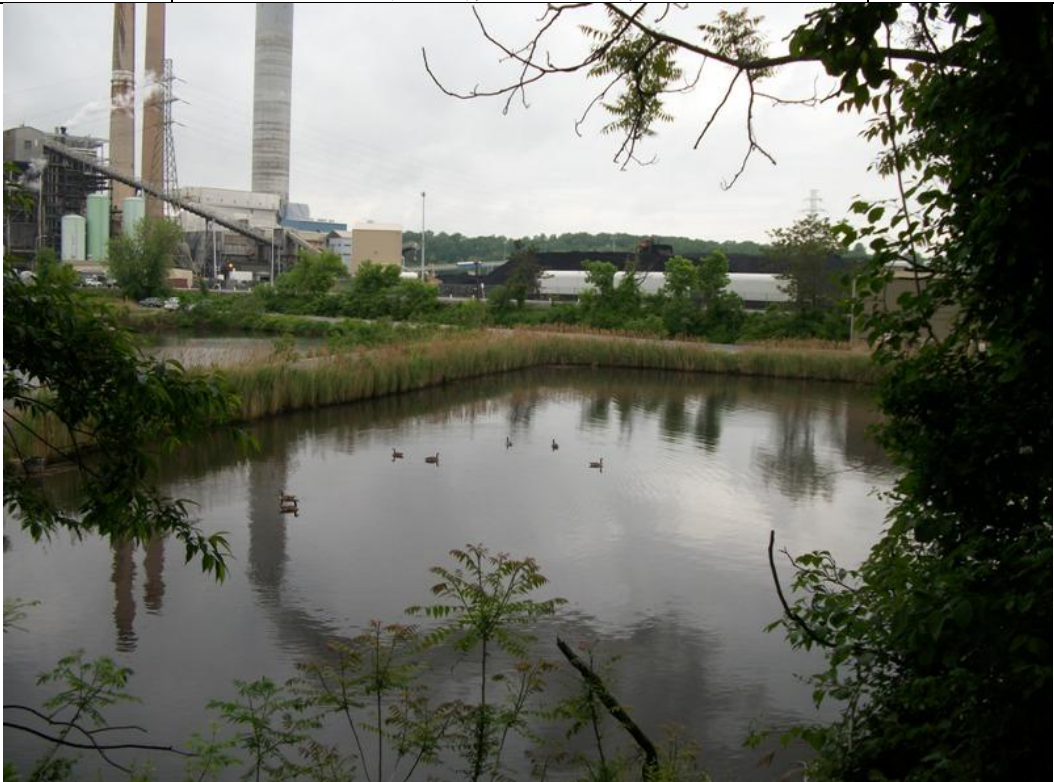
<b>Direction Photo Taken:</b> Southerly			
<b>Description:</b> Overview of north lagoon as viewed from the crest of the Susquehanna Flood Control Levee. Note middle pond is at left.

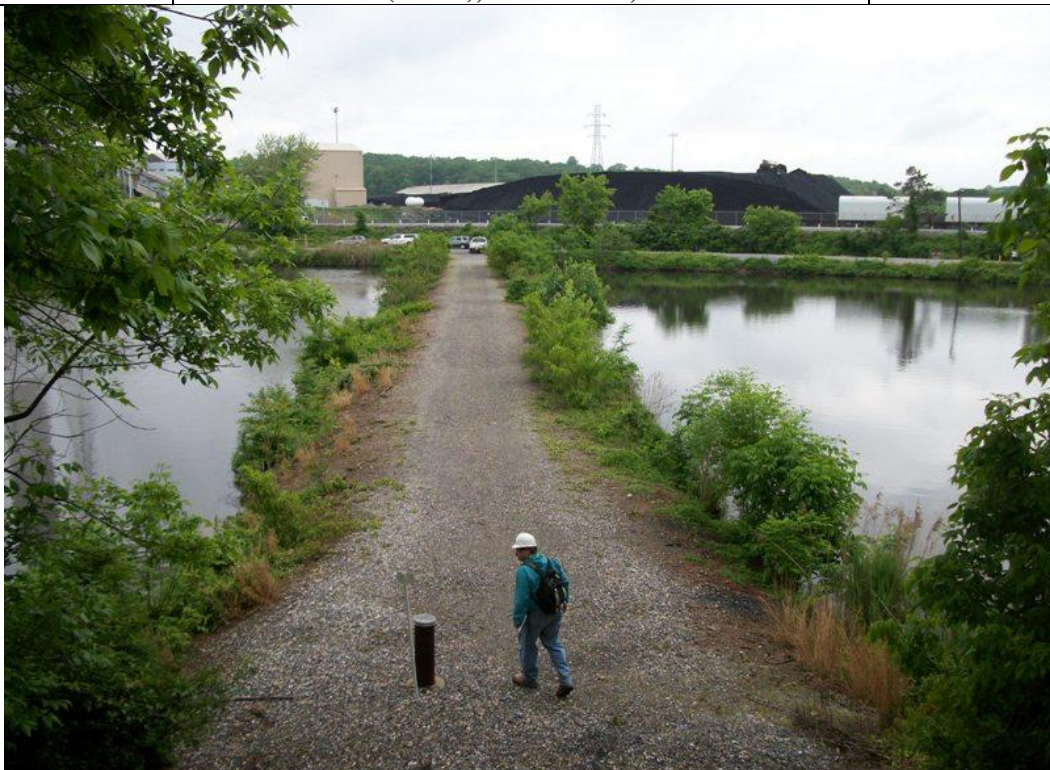
<b>Direction Photo Taken:</b> Southwesterly			
<b>Description:</b> Overview of common dike between the south and middle lagoons from the crest of the Susquehanna Flood Control Levee. Note the ground water quality testing well in the foreground.			
<b>Photo No.</b> 70	<b>Date:</b> 5/18/2011

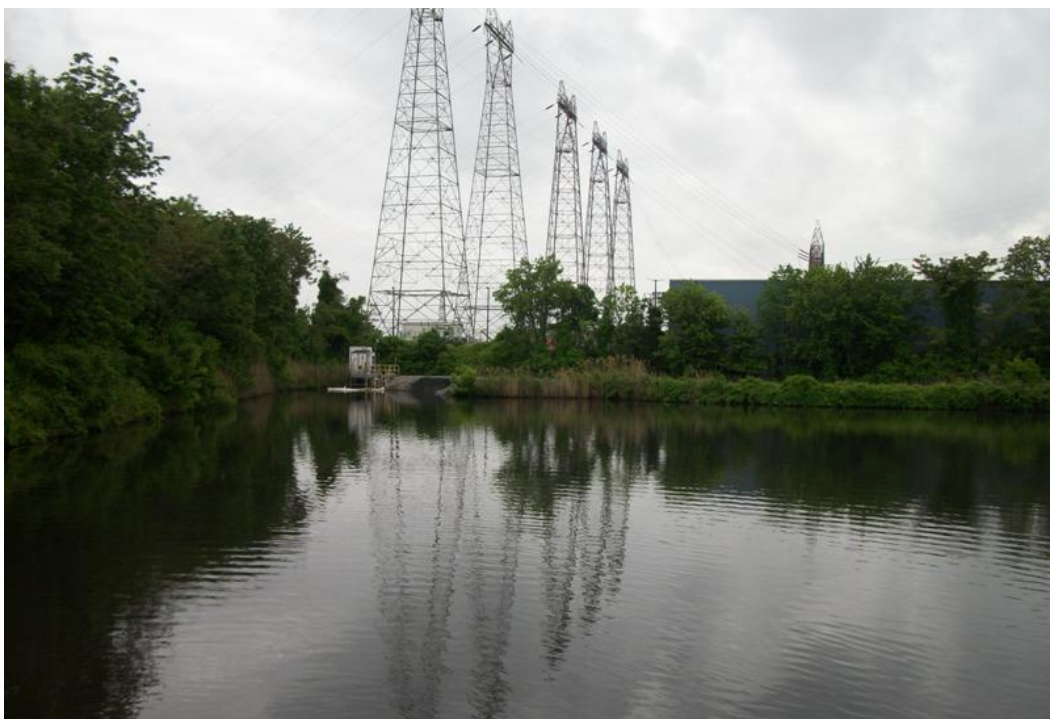
<b>Direction Photo Taken:</b> Southeasterly			
<b>Description:</b> View of south lagoon from common dike between the south and middle lagoons. Note Decant Gate and Sensor Monitoring Structure at left side.

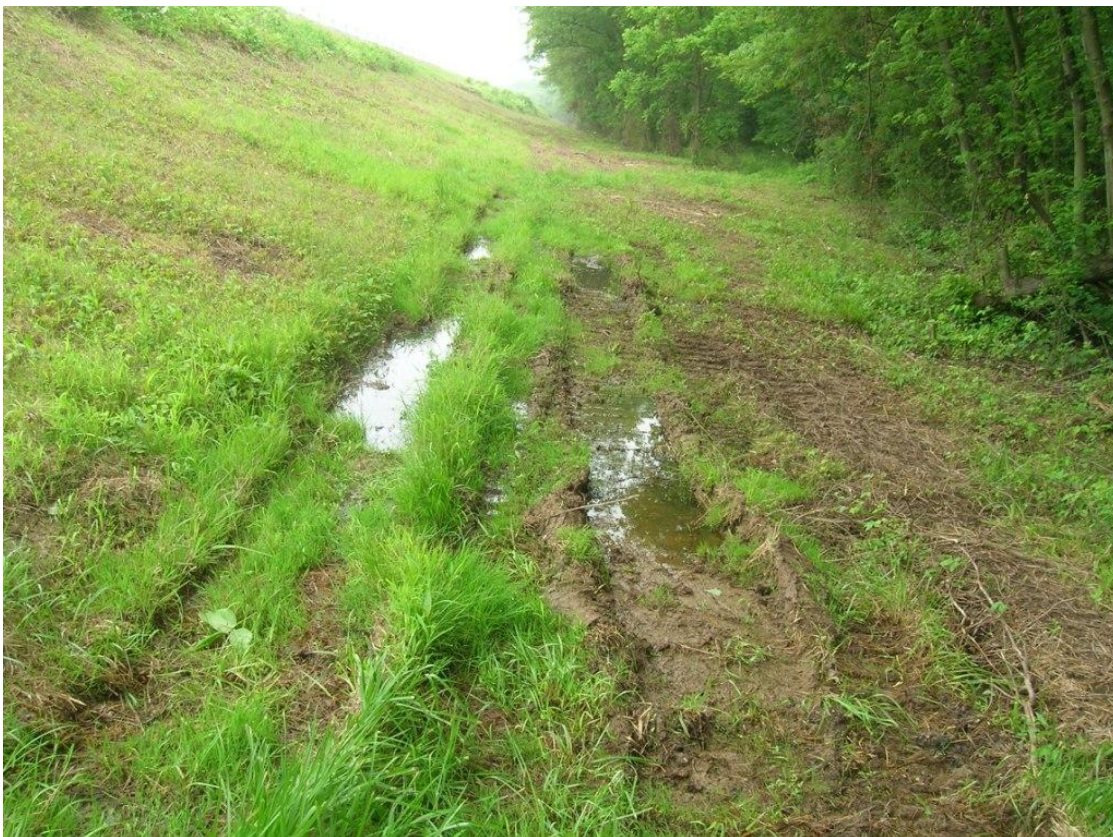
East Embankment at Station 7+44, Section 2-2 – The section height is approximately 30 feet, which is near the maximum height of the downstream slope. The toe of the embankment was observed to be wet at this location with intermittent puddles of standing water near the base of the slope, extending 5 feet up the slope. Water was observed actively seeping from the slope at and near the location of Boring B09-4 and could be audibly heard as it trickled down the slope. The toe was saturated. These observations were not consistent with the piezometer readings, which show the phreatic surface below the ground surface at Sta 7+44. It is apparent that phreatic conditions are not straightforward, as discussed later. Saturation of the slope and toe may be the result of rainfall and high river levels, although there is not enough piezometric data to assess seasonal trends. Open water in the middle sub-basin extends to the upstream face.

Photo 1 – Wet area at toe of the East Embankment, looking north from Sta 0+30. (2009 annual inspection)

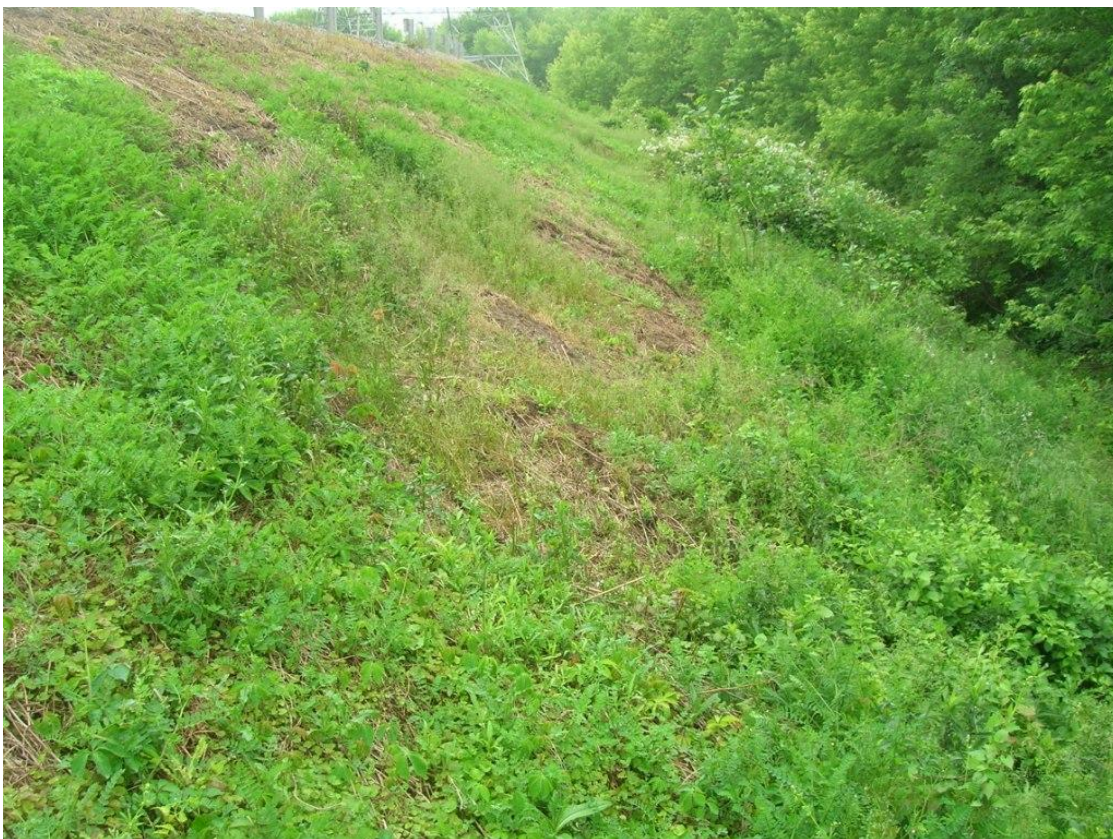
East Embankment at Station 21+80, Section 1-1 – This section was located immediately south of the series of shallow sloughs described previously. The location where the holes were drilled obviously has a somewhat higher factor of safety with respect to shallow slides than the slide area, but the expectation is that this section was likely marginally stable at the time the adjacent sections slid. Wet soils were observed on the embankment face approximately 1/3 of the way up the slope and the toe was saturated, possibly indicating a high phreatic surface. A channel carrying free water is present at the upstream face. The section height is approximately 25 feet, slightly less than the maximum section height.

Photo 2 – Slope sloughing in the East Embankment, looking north from Sta 22+10. (2009 annual inspection)

- Repair the existing sloughed areas.
- Drawdown the reservoir if significant tailwater flooding is forecast. While this is not expected to have a major effect, it may reduce the likelihood of progressive failure.
- Continue monitoring piezometers on a monthly basis until annual trends can be established.

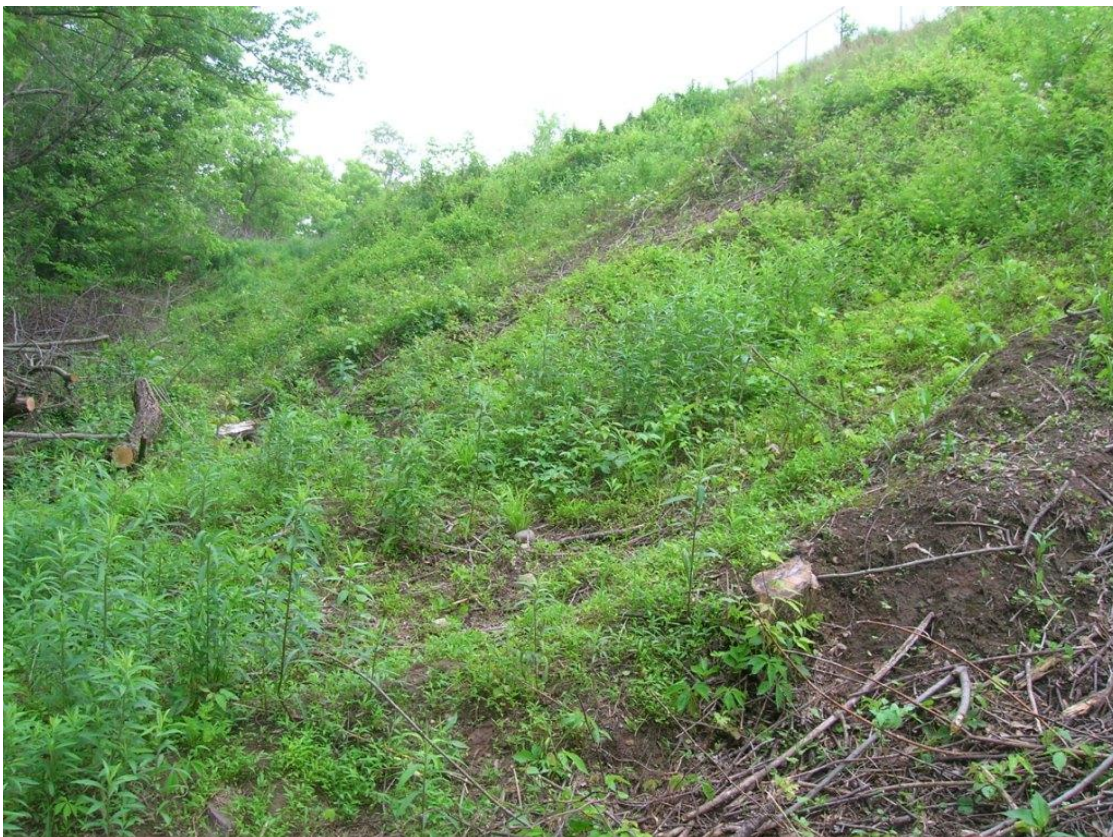
Photo 3 – Slope slough near the north end of the West Embankment.

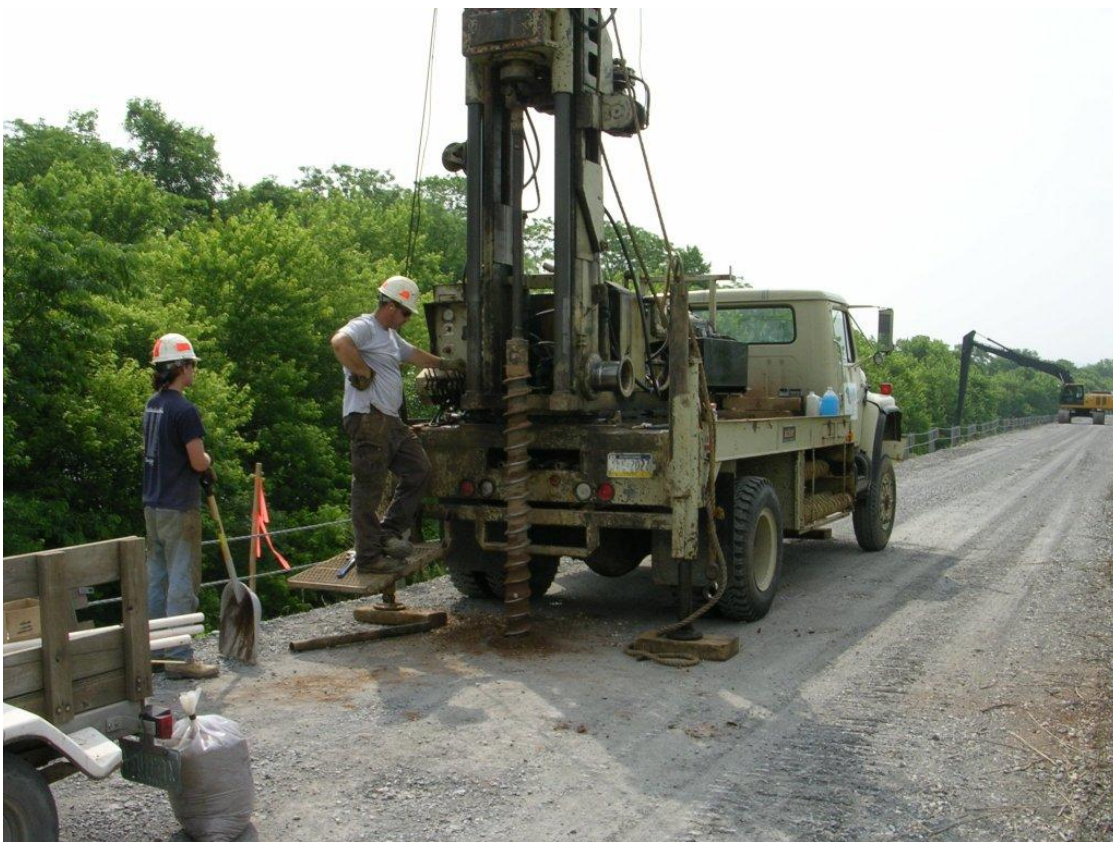
Photo 4 – Advancement of Borehole B09-1 at Sta 21+80 using truck-mounted drill rig.

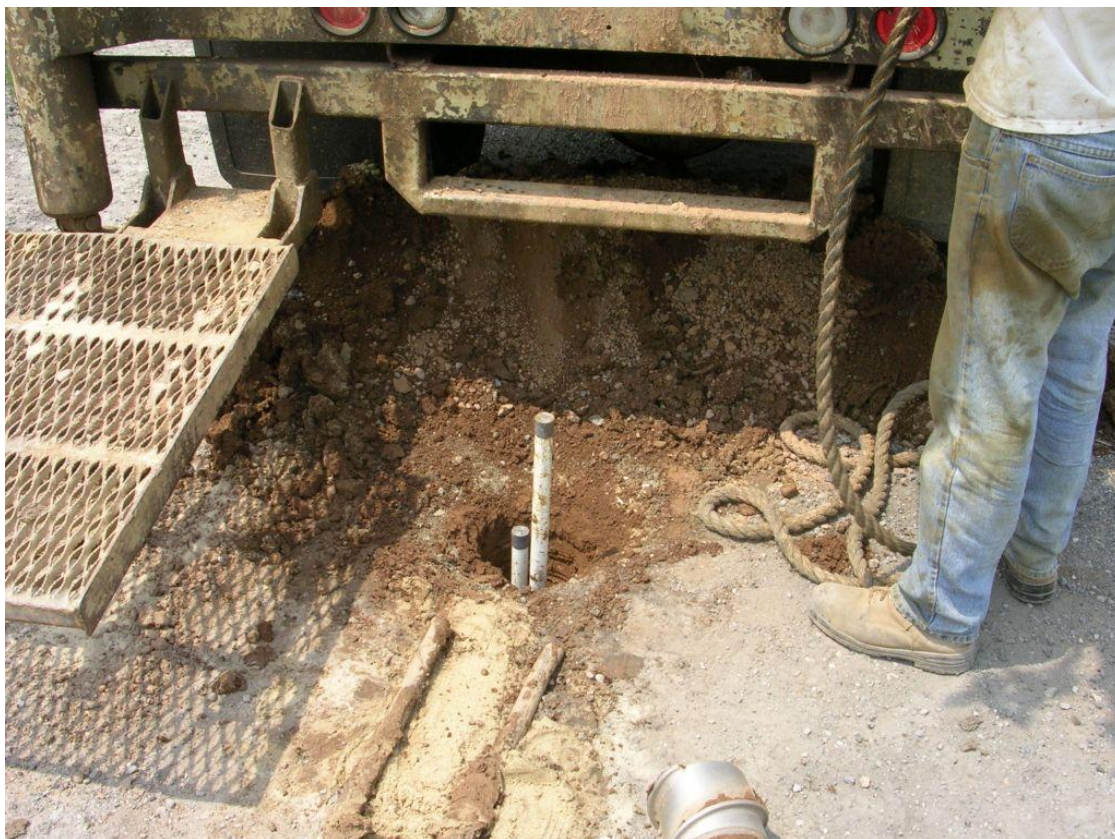
Photo 5 – Two piezometers installed at Borehole B09-3 with different screen intervals.

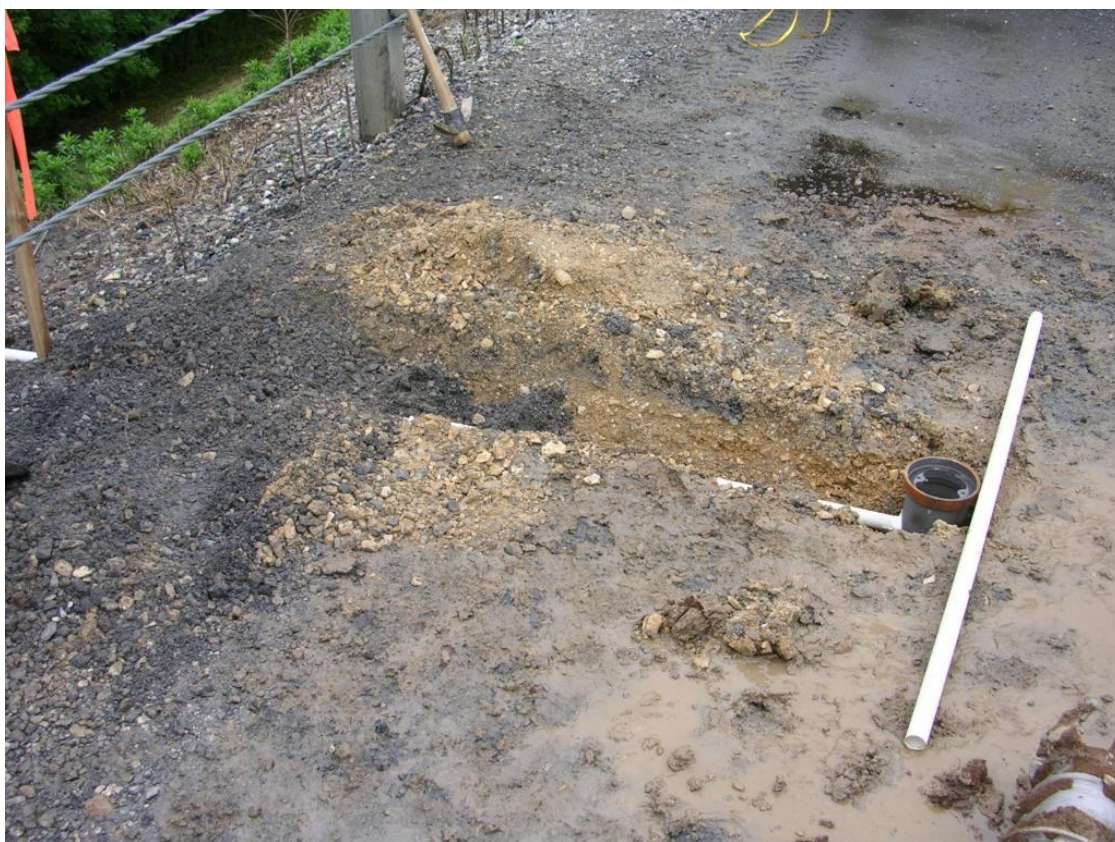
Photo 6 – View of typical trench dug for installation of drain pipe from piezometer cover.

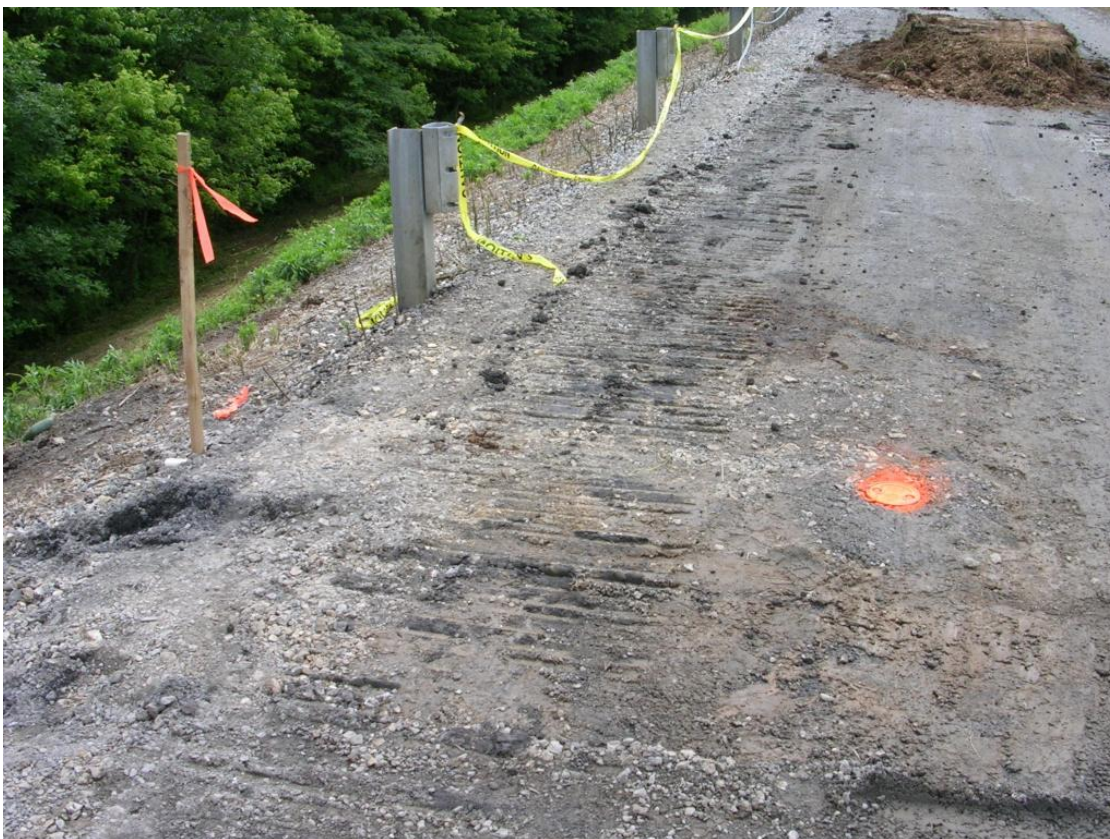
Photo 7 – Crest boring and piezometer cover marked to avoid disturbance during later work at the site. Note the removal of the guardrail cable for downslope access.

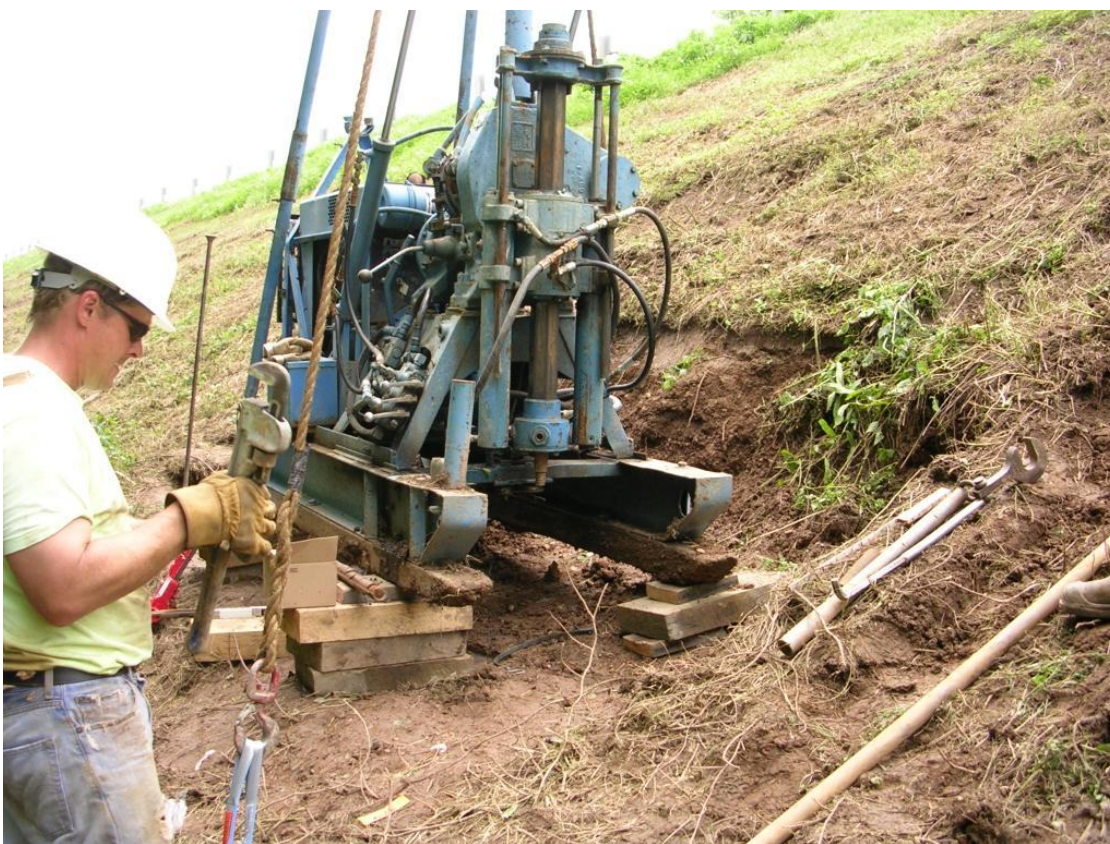
Photo 8 – Typical placement of skid-mounted drill rig at downslope borings.

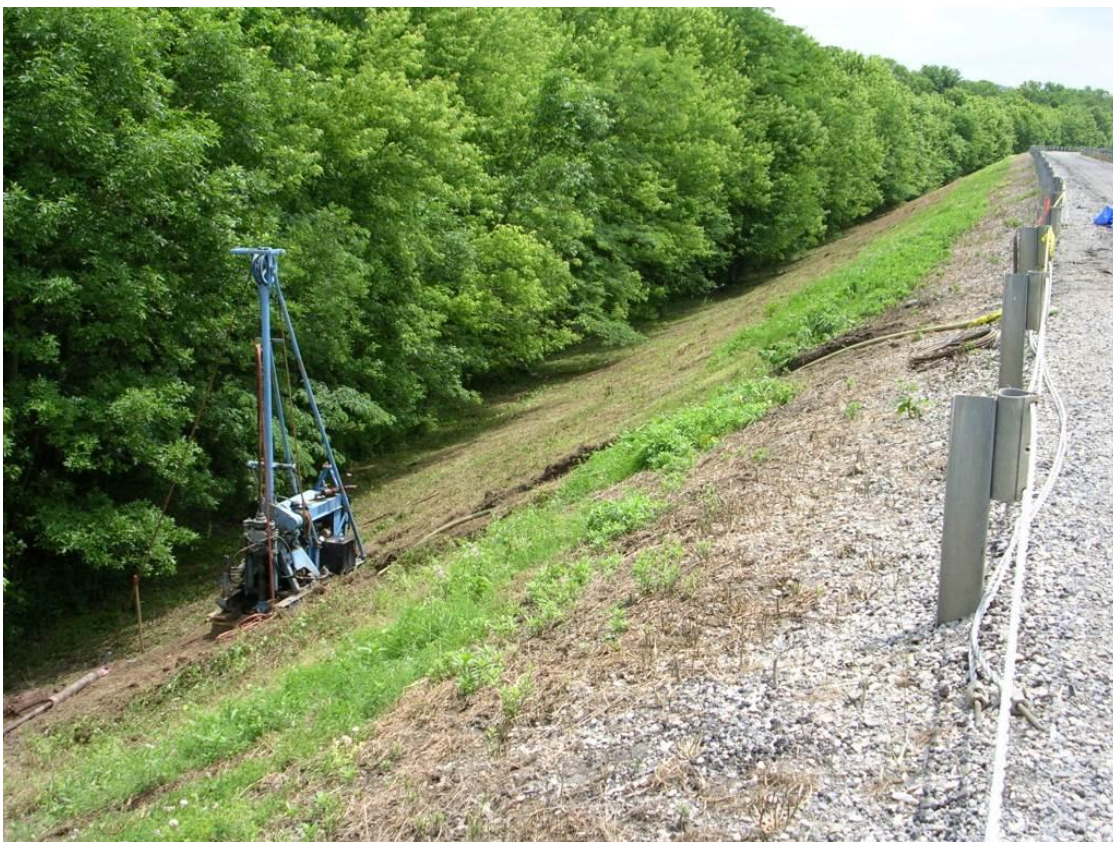
Photo 9 – View of drilling site looking south, adjacent to Sta 21+80.

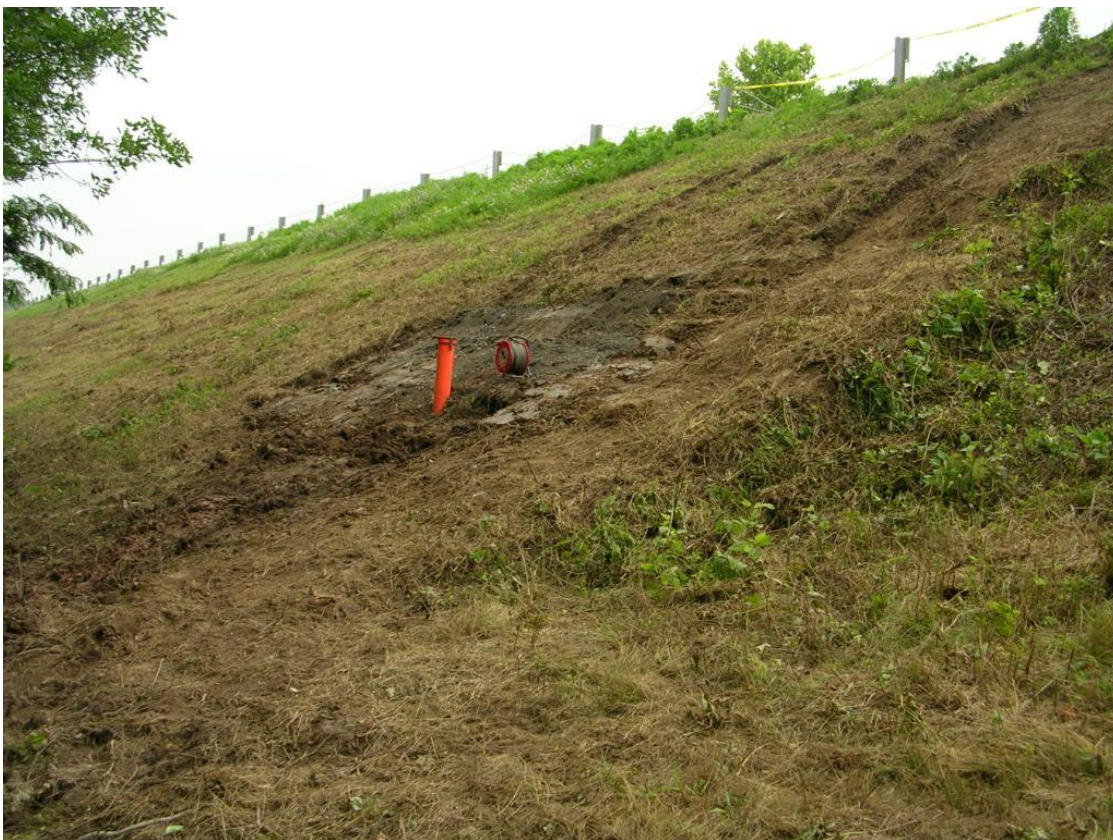
Photo 10 – Marked piezometer standpipe cover at completed Borehole B09-2.

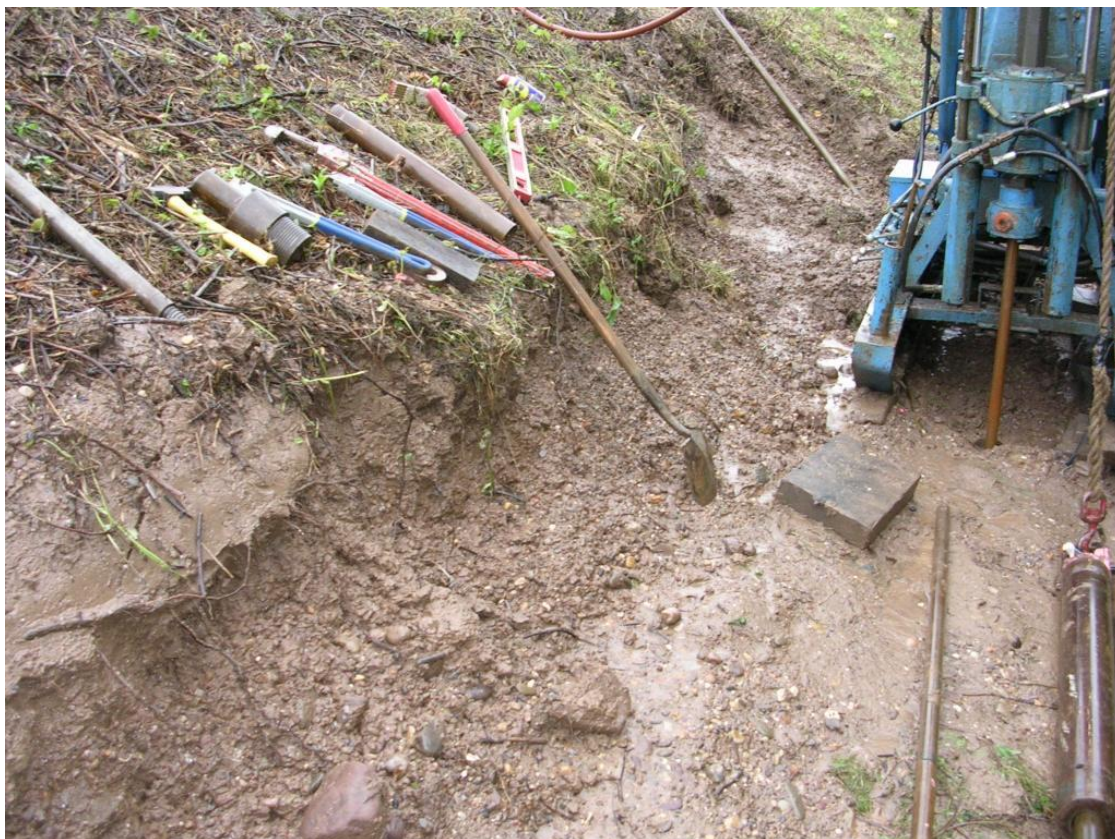
Photo 11 – Wet ground surface conditions during drilling of Boring B09-4, especially evident after digging of bench area.

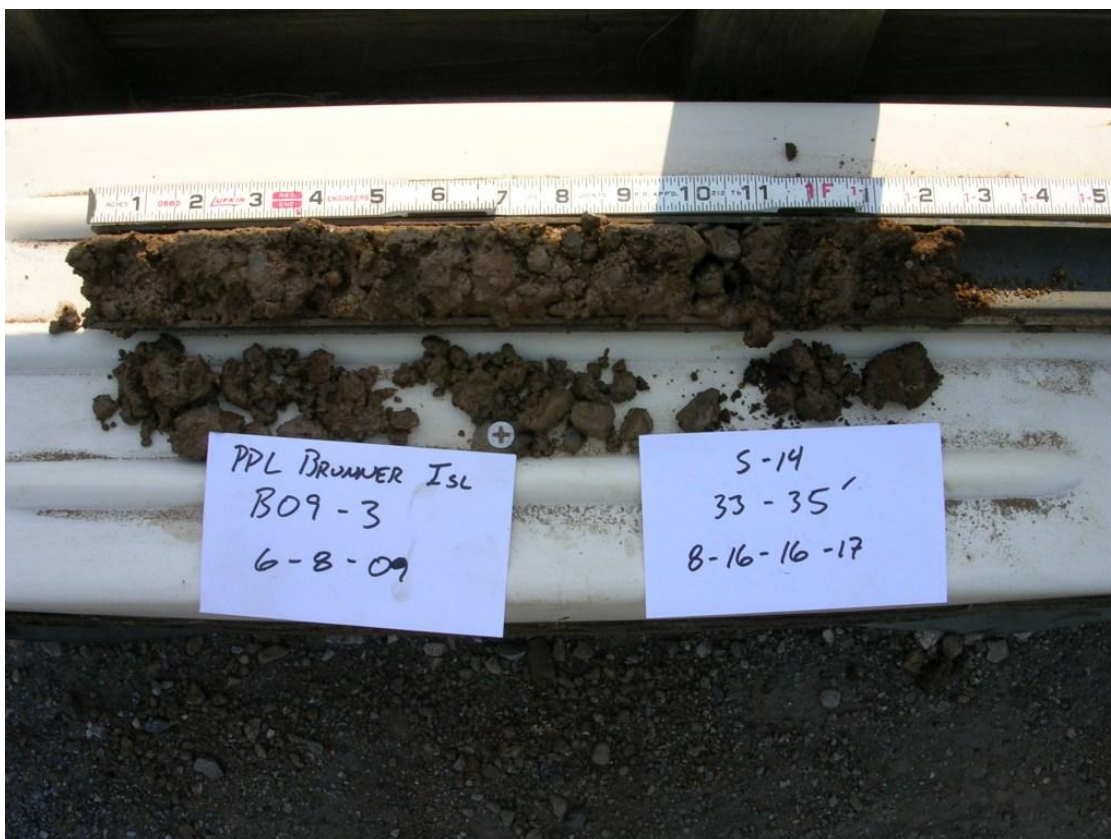
Photo 13 – Split-spoon sample of foundation soil from Boring B09-3, consisting of dense silty sand with gravel.

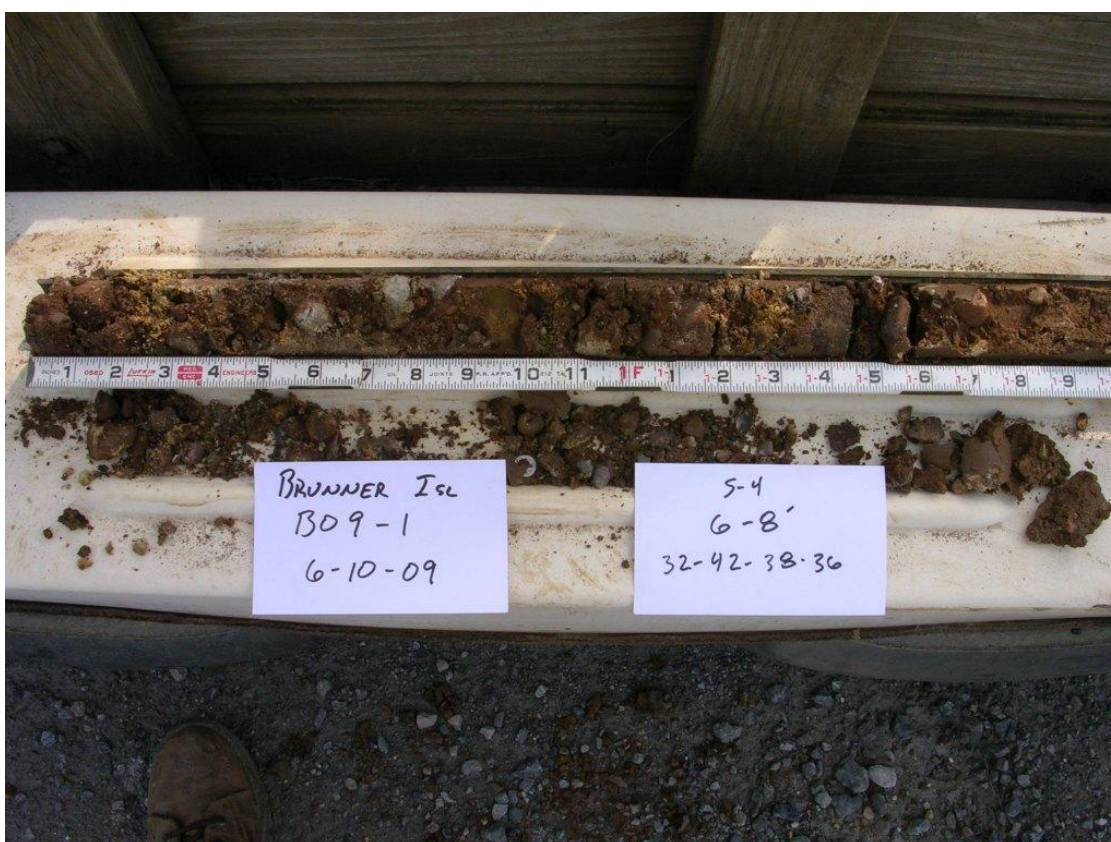
Photo 14 – Split-spoon sample of embankment fill material from Boring B09-1, consisting of gravelly silt with fine to coarse sand.

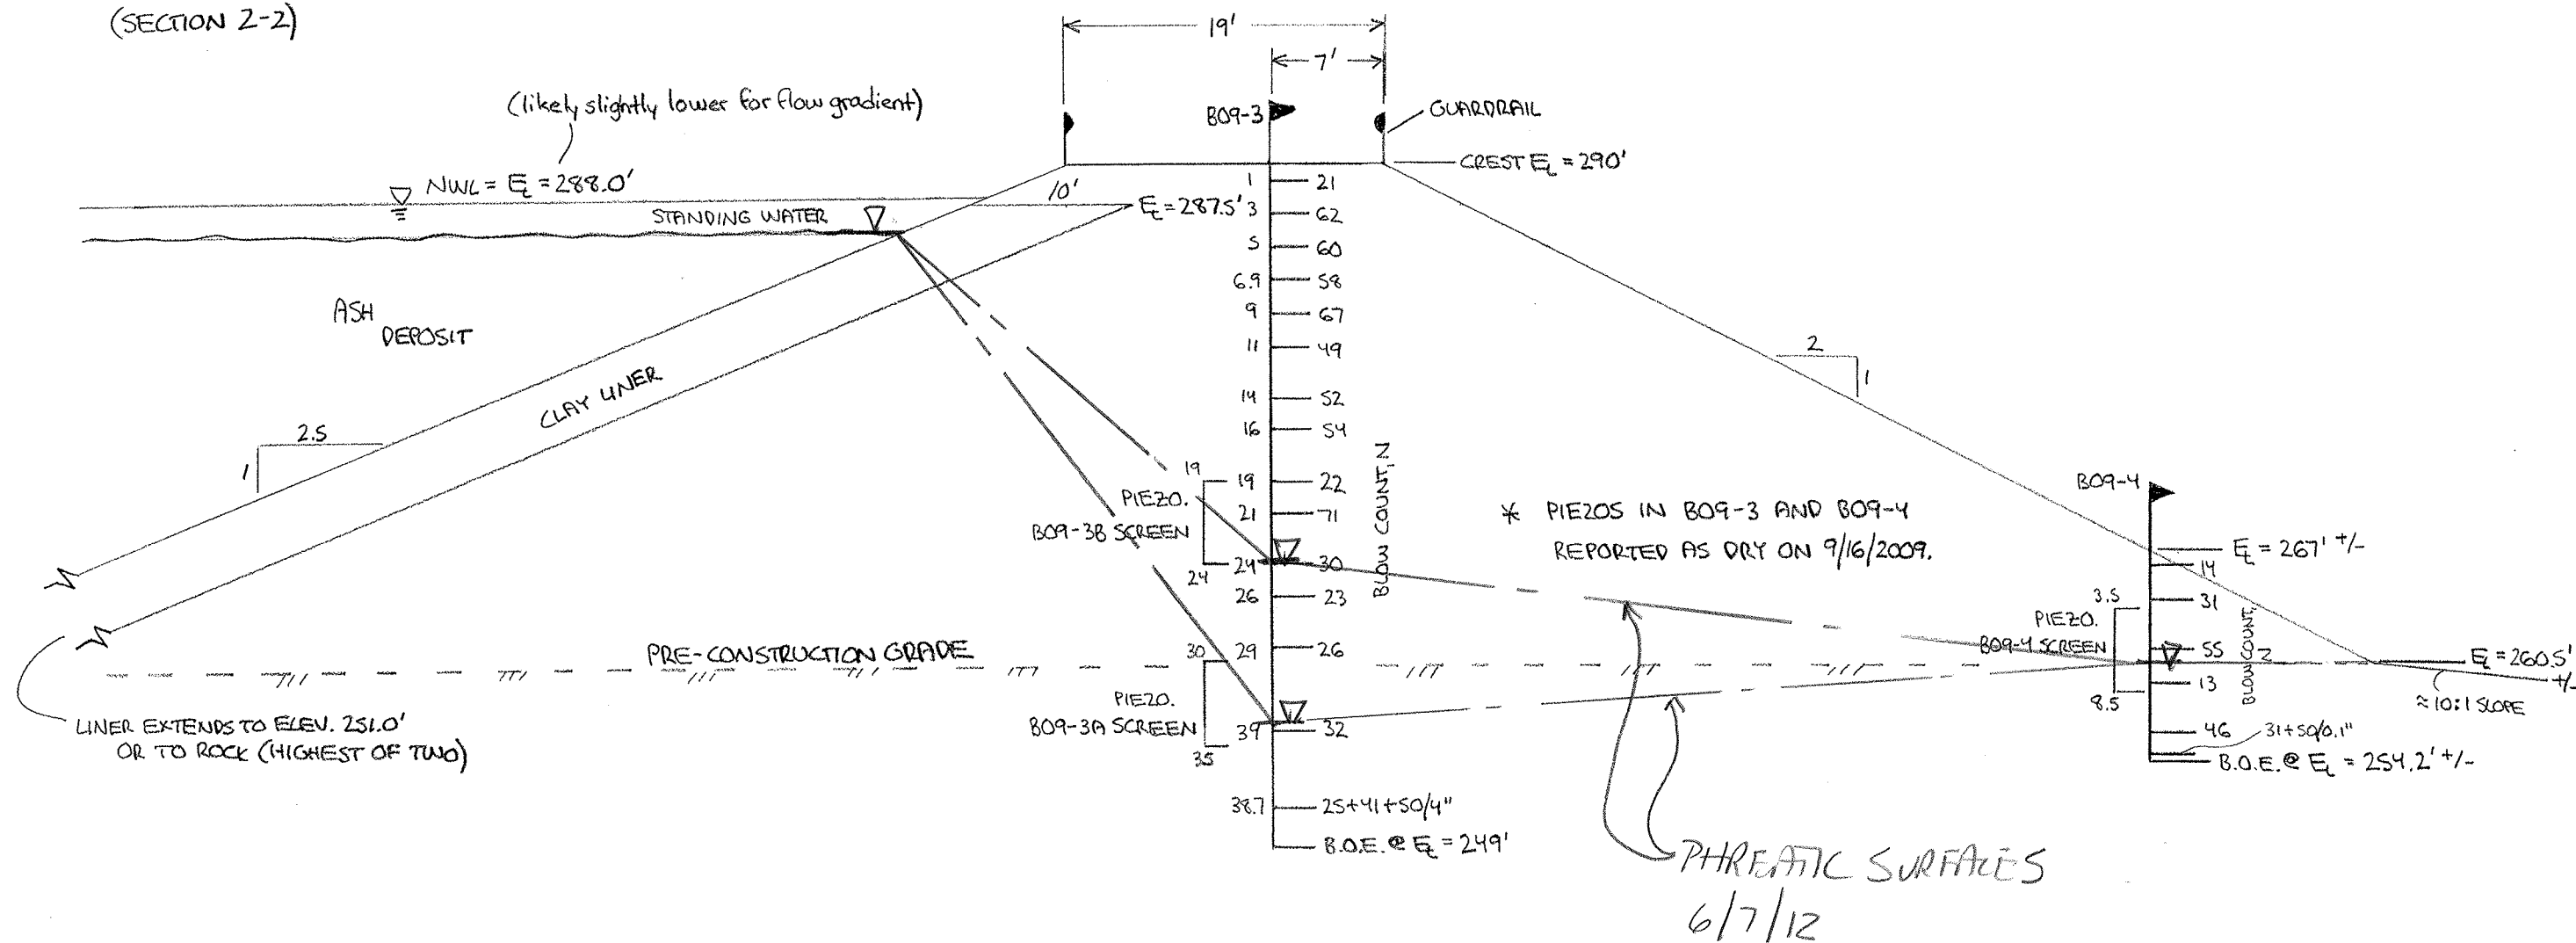
FIGURE 2

Variations in the phreatic surface were observed between the two cross sections in which piezometers were installed, as seen on Figures 2 and 3. It was apparent that the observed seepage at Station 7+44 was the result of an isolated permeable zone that was not reflected by the piezometers, or by capillarity or some other cause. The embankments were constructed with an

STATION 7+44 +/-:  
(SECTION 2-2)
